# EN-CORE/fib Round Robin Testing Initiative

## Round Robin Tests 1.2

### *Tensile tests on bars/strip for NSM*

Report N.º 10-DEC/E-23

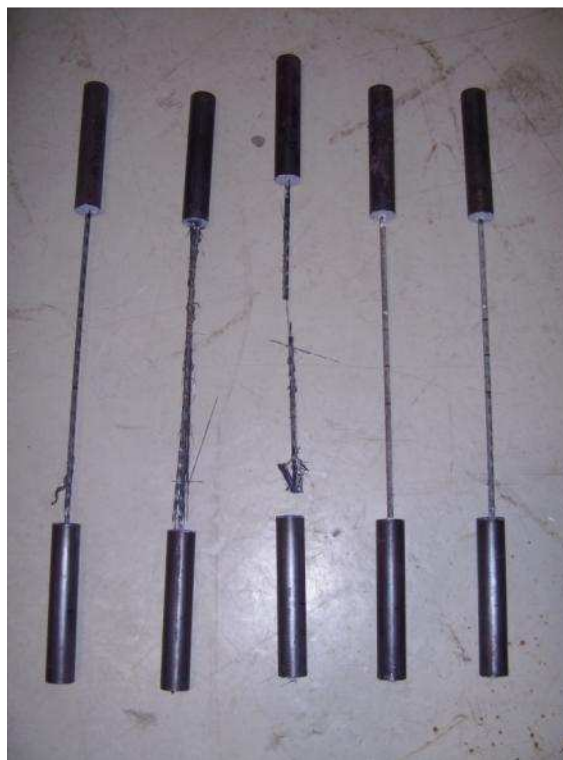
**Figure 4.1.1** – Tested specimens

Anchorage: Failure of the FRP close to the anchorage

Debonding: Debonding of the FRP inside the adhesive

**Description of failure mode:** Since in general a significant slip of the bar inside the anchorage system was verified, a longer anchorage length seems recommended for future tests.

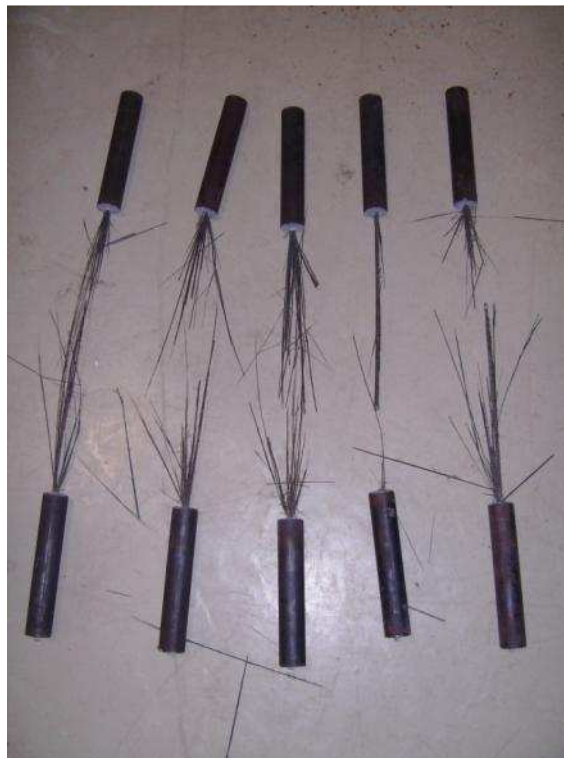
**Figure 4.2.1** – Tested specimens

LS: longitudinal splitting and fibre fracture

**Description of failure mode:** Explosive.

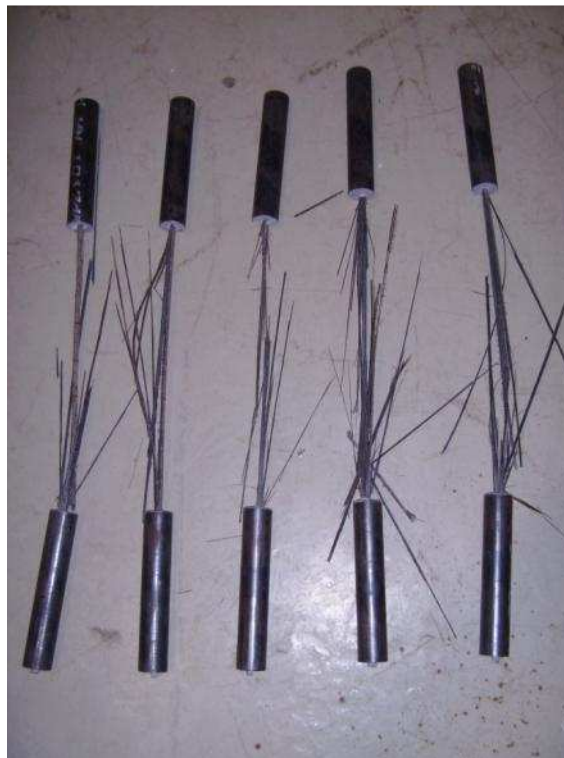
**Figure 4.3.1** – Tested specimens

LS: longitudinal splitting and fibre fracture

**Description of failure mode:** Explosive, although less than the corresponding bars of lower diameter.

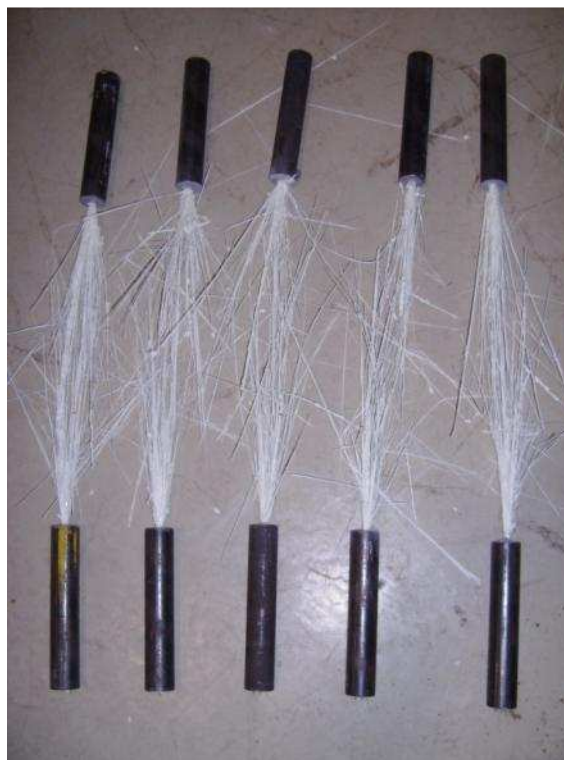
**Figure 4.5.1** – Tested specimens

LS: longitudinal splitting and fibre fracture

**Description of failure mode:** Explosive followed by small fibres all around.

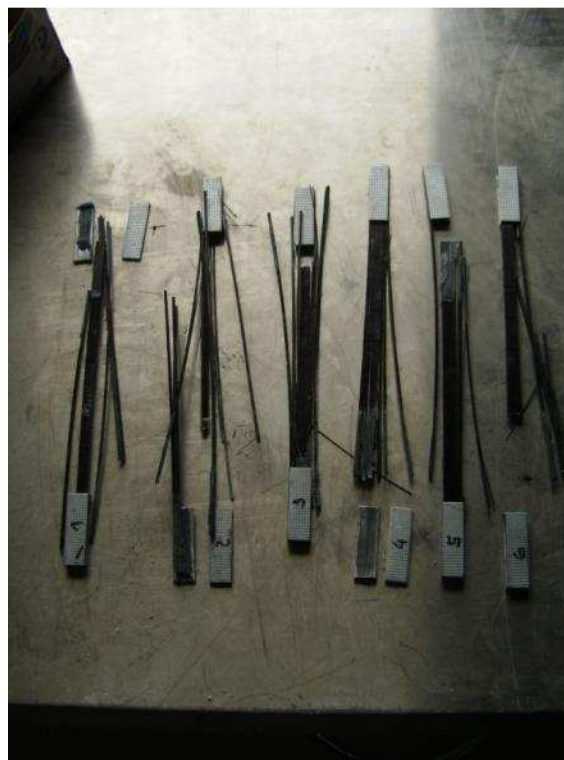
**Figure 4.6.1** – Tested specimens

LS: longitudinal splitting and fibre fracture

**Description of failure mode:** Not much explosive, and not too messy. However, the type of failure occurred did not correspond exactly to the one expected. The fibres split longitudinally but fractured too close to the end tabs.

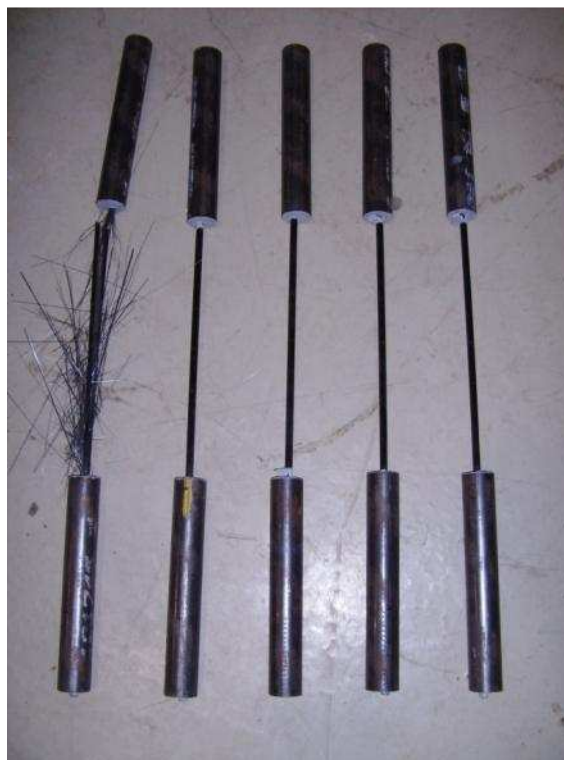
**Figure 4.7.1** – Tested specimens

LS: longitudinal splitting and fibre fracture

PO: Pull-out bars

**Description of failure mode:** The first specimen only failed because it was accidentally pre-compressed. In all other cases, the anchorage length was insufficient. In most of the specimens the bar was debonded from the adhesive.

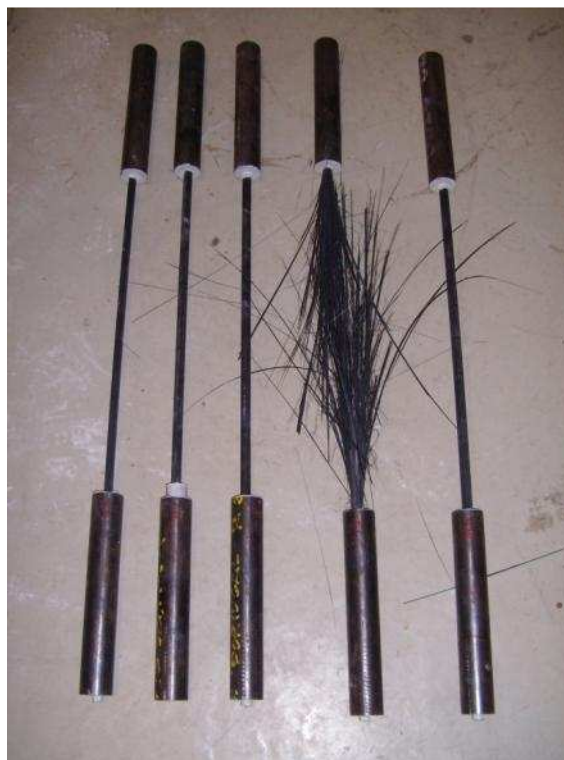
**Figure 4.8.1** – Tested specimens

PO: Pull-out bars

**Description of failure mode:** Only one specimen has ruptured. In spite of using an anchorage length of 250 mm in these specimens (the maximum in all test program), the other four did not fail. It seems that with a little higher anchorage length the rupture of these bars can be attained.
